Coal Mine Fatal Accident 2003-20

Operator:	Highland Mining Co.
Mine:	Highland 9 Mine
Accident Date:	July 2, 2003
Classification:	Machinery
Location:	District 10, Union Co., Kentucky
Mine Type:	Underground
Employment:	229
Production	12,000 tons/day

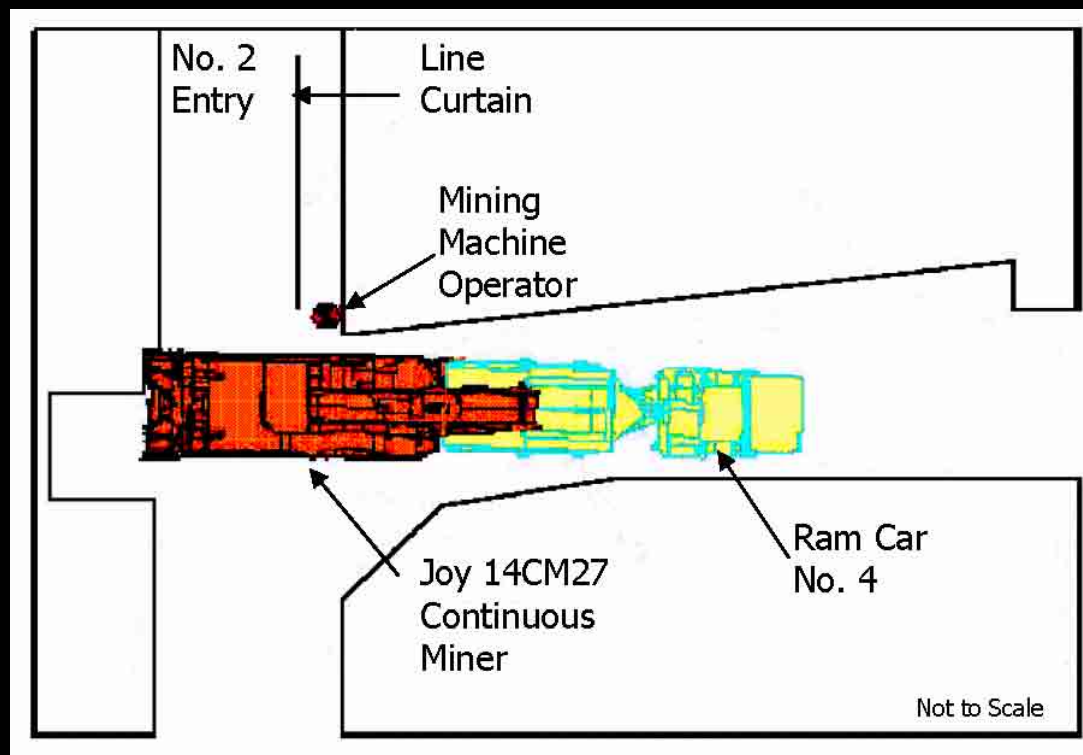
- Coal was mined using a remote-controlled continuous mining machine with ram car haulage.
- At 3:15 p.m., the mining machine operator was positioned near the 2 Left intersection, to the right of his machine, as shown above.

- **Causal Factor:** The continuous mining machine operator was positioned within 19' of the working face.
- **Corrective Actions:** When adverse conditions exist such as mining roof-rock, and pyritic nodules, the mining machine operator should be positioned at as great a distance from the face as possible and appropriate PPE should be utilized.
- **Causal Factor:** The shrapnel struck the victim in the neck causing serious injury, which resulted in a fatality.
- **Corrective Actions:** Mining companies, manufactures, and other interested parties should continue research to develop personal protective equipment that will afford better protection for the miner and also identify proper machine and component configurations for such applications.

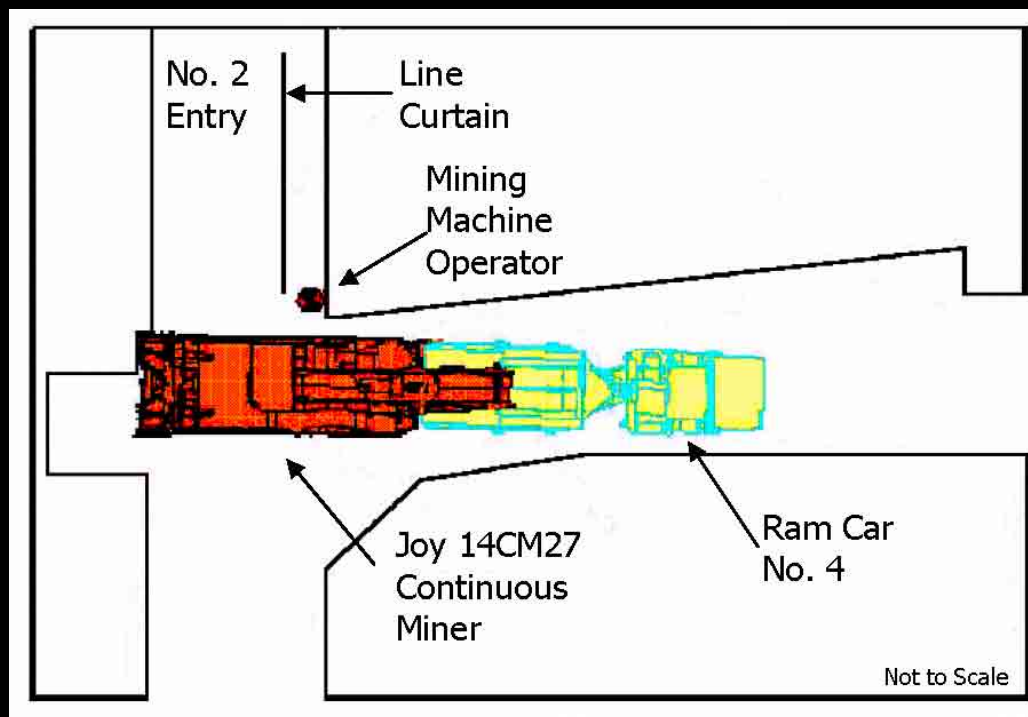
- 18" was mined from the right side lift.
- The ram car operator noticed the mining machine operator flinch.
- The mining machine operator grabbed his neck, walked to the ram car, stated he was bleeding, and collapsed.
- The ram car operator realized that the mining machine operator was seriously injured and summoned help.

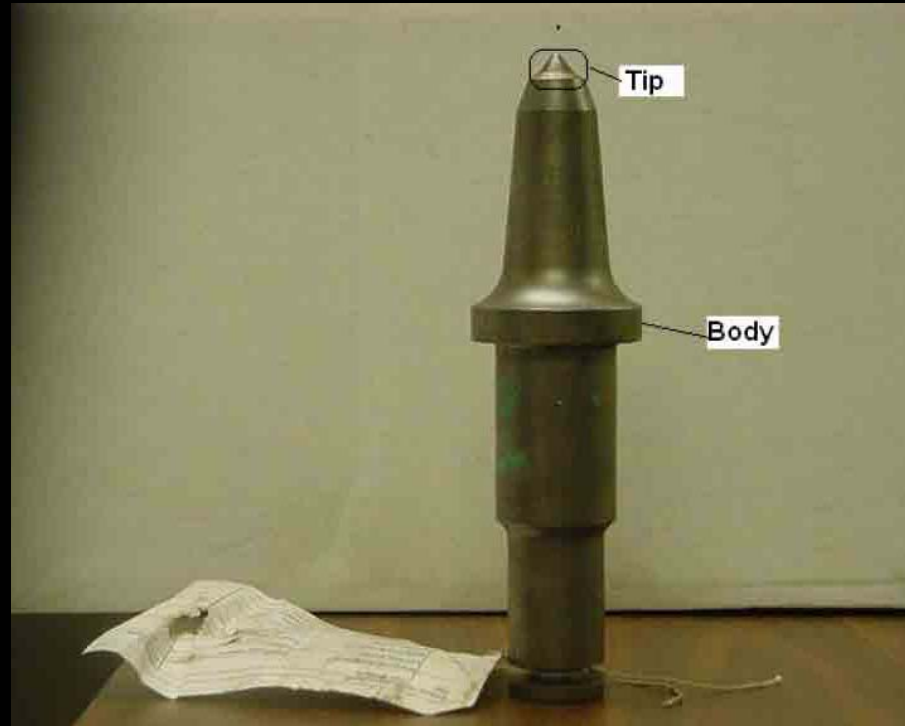
- The mining machine was fitted with Kennametal U170 4.0 16s bits.
- A notice was attached to the bit container warning of the safety risk in using dull bits.
- There were 55 miner bits on the mining machine's cutting head.

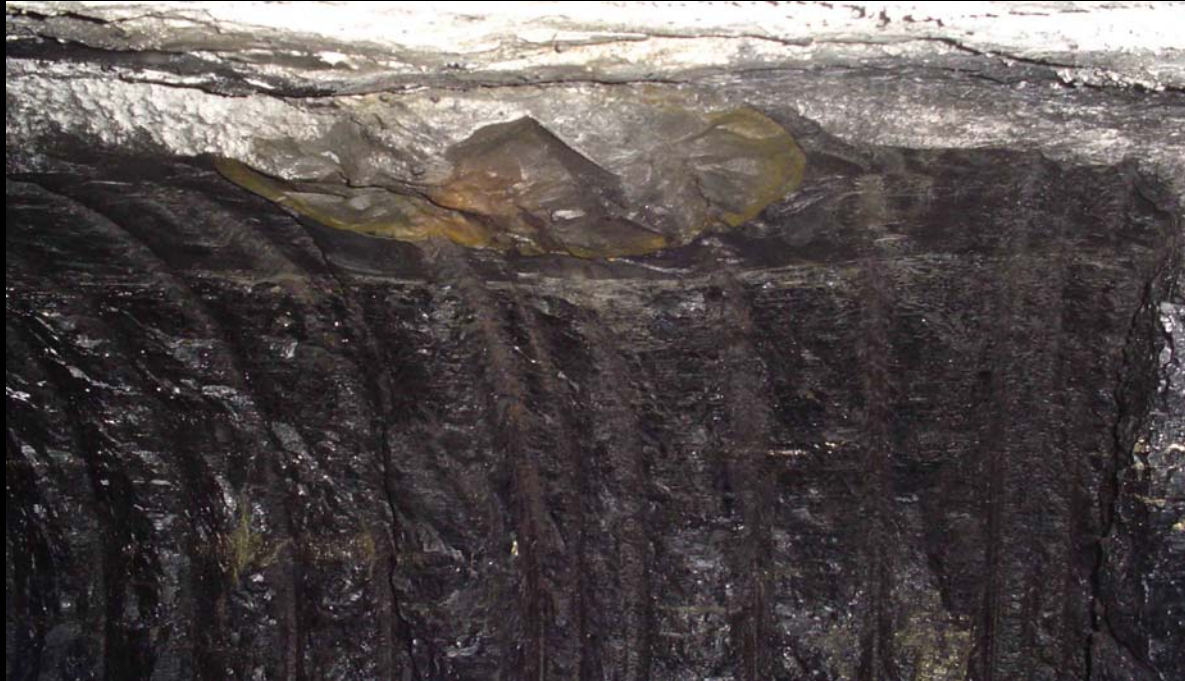
- Numerous small carbonate nodules with extensive pyritic dissemination were encountered in the mine roof.
- These nodules are extremely hard to cut due to the density of their carbonate makeup.

- **Causal Factor:** The presence of a carbonate nodule in the mine roof measuring roughly 14" in by 12" and numerous other small carbonate nodules with extensive pyritic dissemination were encountered in the mine roof.
- **Corrective Actions:** When carbonate nodules with extensive pyritic deposits are encountered in the mine roof the operator should first mine directly under the deposits to create a free face in attempt to jar the nodules loose.
- **Causal Factor:** The bit lost its tungsten carbide tip causing the steel bit body to come in contact with a carbonate nodule. The cutting bit body repeatedly impacted the carbonate nodule resulting in the shrapnel being generated.
- **Corrective Actions:** When adverse roof conditions of this nature are encountered, cutting bits should be visually examined prior to and frequently during the operation and replaced as necessary.

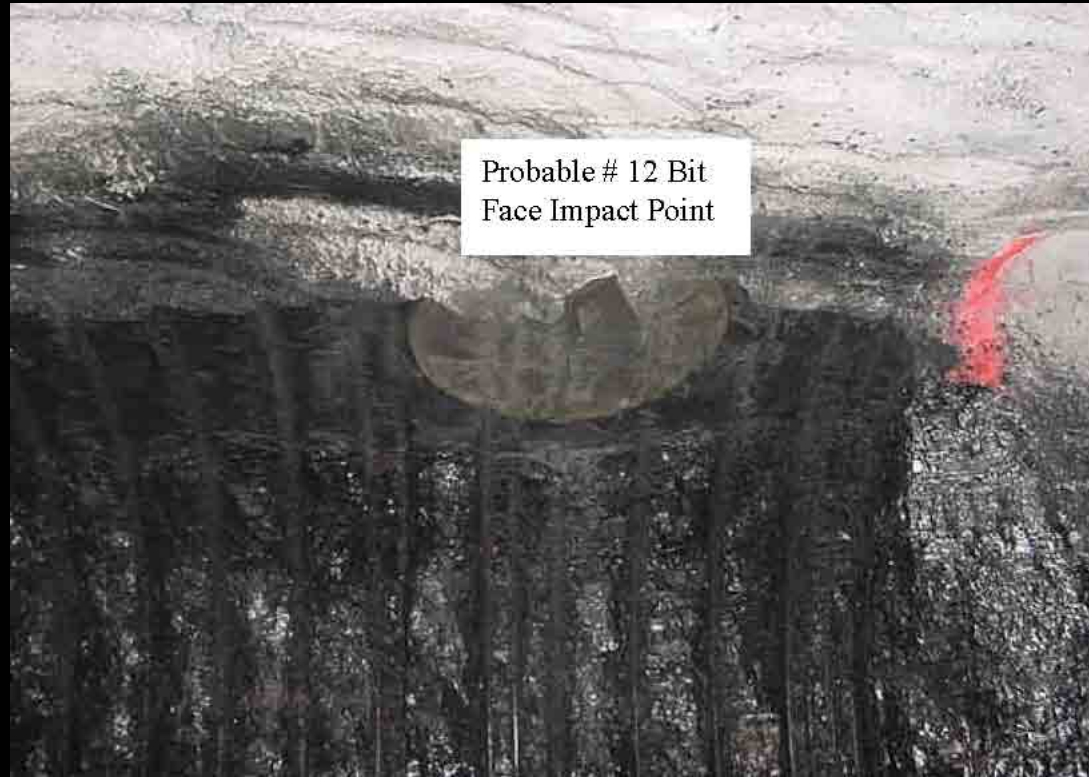
- At the time of the accident the bits on the cutter head encountered a carbonate nodule in the mine roof.
- The bits contacting the carbonate nodules generated a significant amount of sparks.

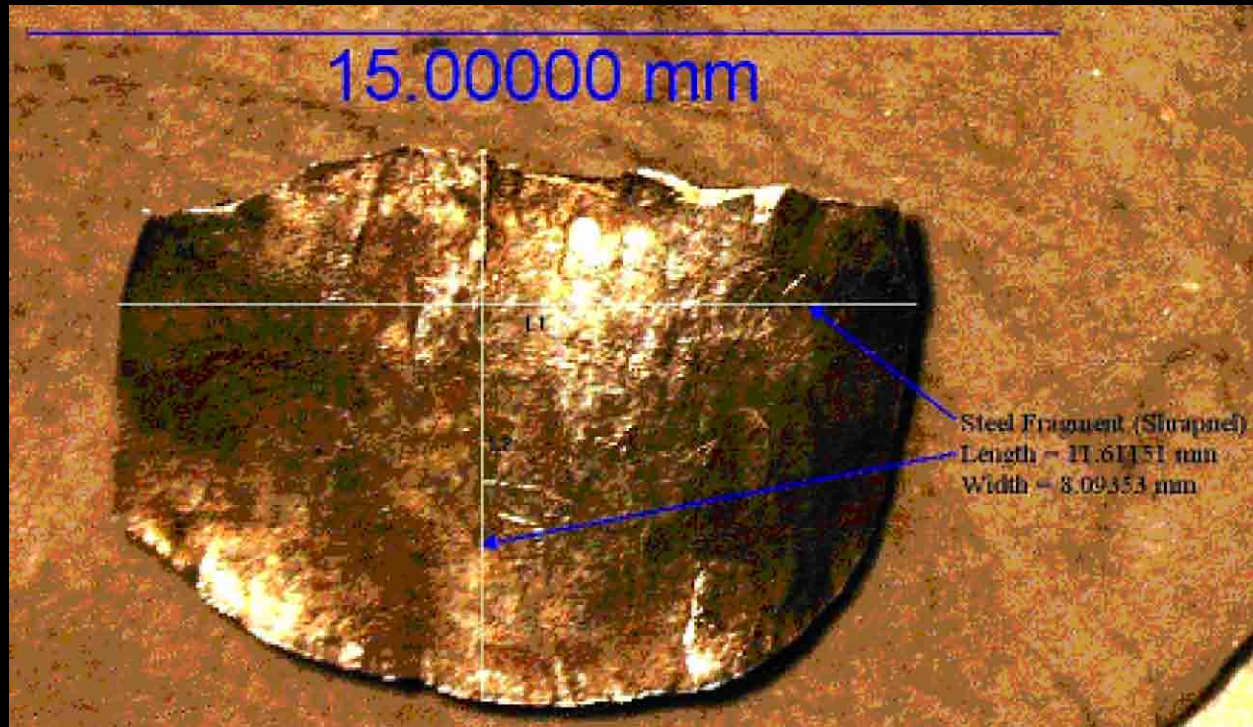
- A piece of steel recovered from the victim's body was wedge-shaped, measuring 0.46" x 0.32" x 0.27" thick at the base tapering to a sharp edge.

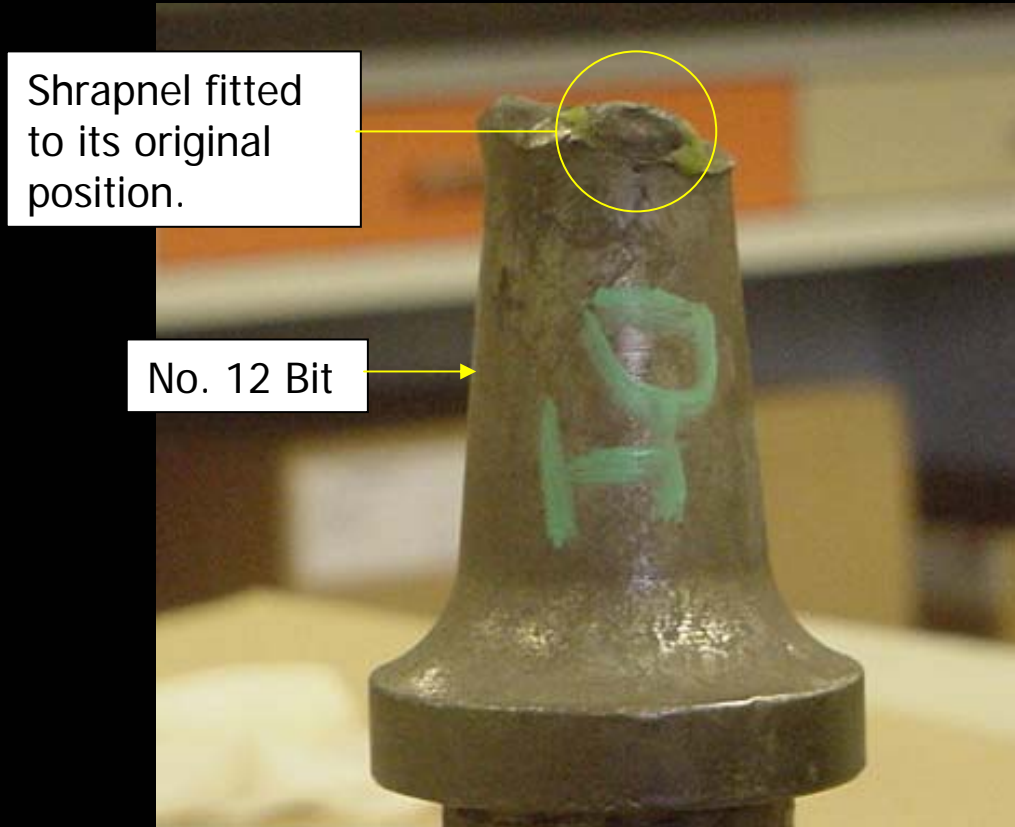
No. 12 Bit

Shrapnel fitted to its original position.

- The bit had lost its carbide tip during or prior to cutting through the large carbonate nodule on the right side of the lift.

- The victim was fatally injured when a piece of shrapnel from a cutting bit struck him in the neck, causing severe bleeding. The shrapnel was generated by the breaking of a cutting bit as it struck a high-density carbonate nodule in the mine roof.
- The direct cause of the accident was breakage and fragmentation of the No.12 bit on the continuous mining machine's cutting drum as it impacted a carbonate nodule. Bits are not to be used when the tip (insert) is missing. The root cause of the accident was lacking or missing procedures for safely mining when carbonate nodules are encountered. These include the following when such conditions are present: undermining where possible; locating the operator farther from the machine; examining for and replacing broken bits more frequently; using personal protective equipment; ensuring the machine configuration is appropriate for the conditions.

- **Inspect bits for wear or damage and replace them when either is observed.**
- **Ensure that all water sprays are operating properly to cool cutting bits, particularly when cutting rock.**
- **Evaluate equipment during repairs, removing any metal burrs and determining if further repairs are necessary when scraping of metals is obvious.**
- **Wear personal protective equipment at all times.**

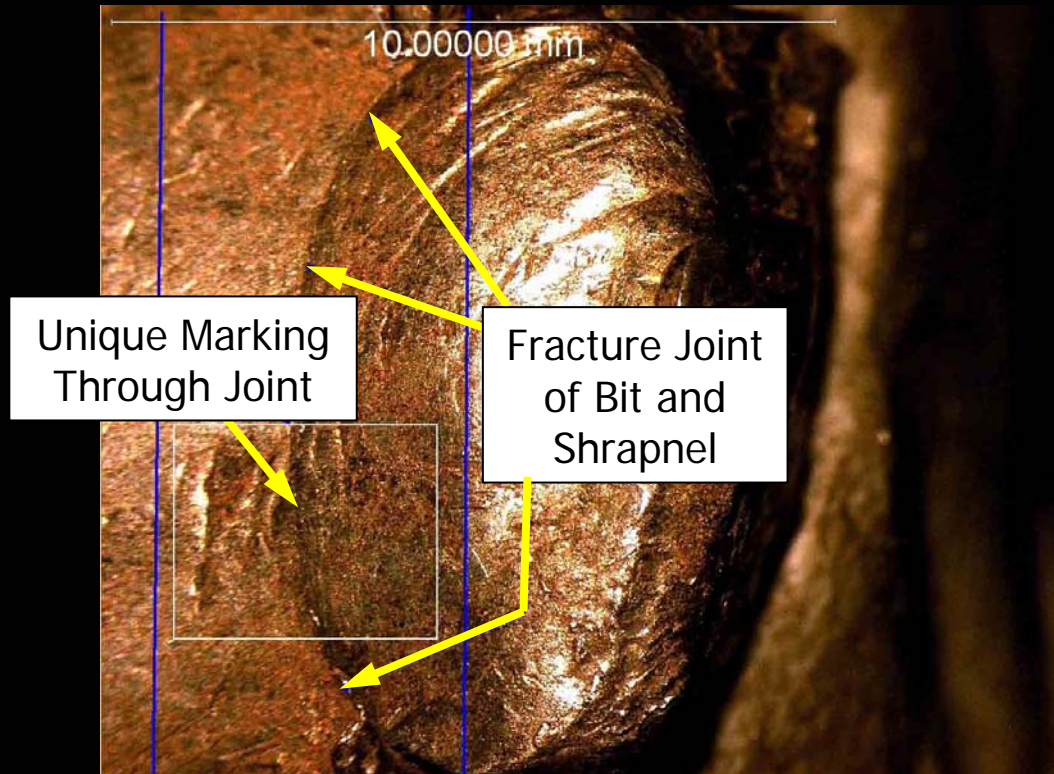
- The material was found through microscopic evaluation to be from the body of the No.12 bit.

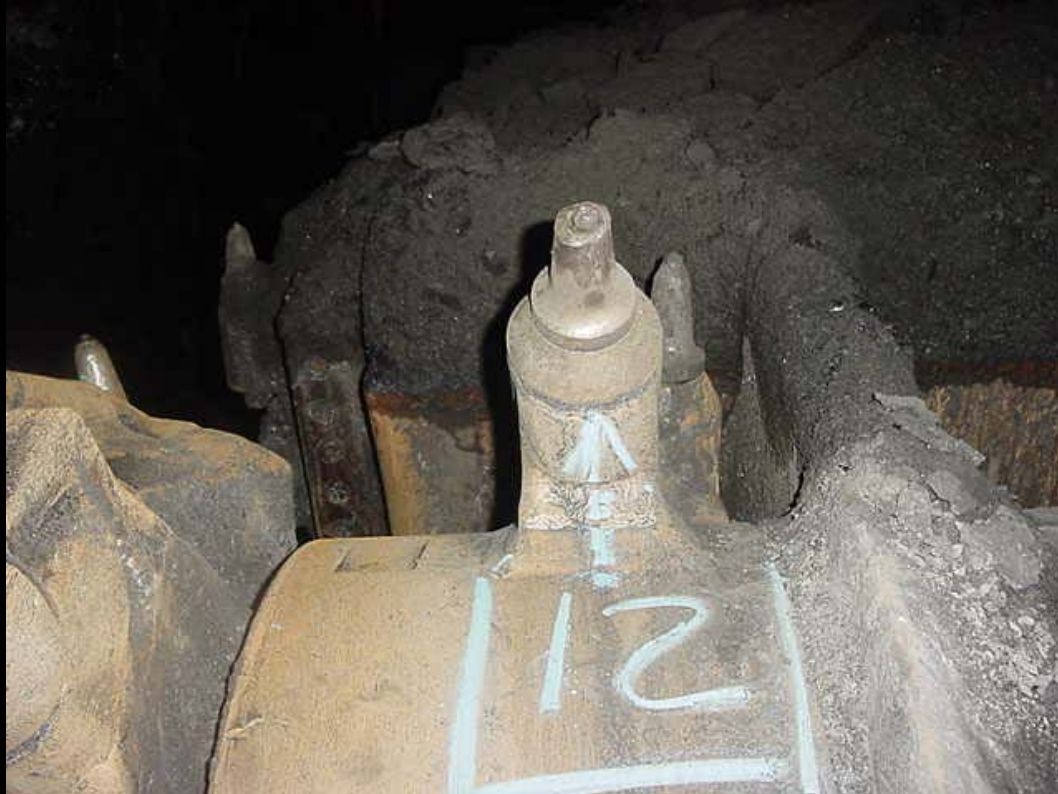
- The image shows the No. 12 bit, still located on the cutting head after the accident.
- The cutting head rotated approximately 59 times/minute.
